# **TANK 305 API 653 TANK INSPECTION Final Report**

**Ploiesti, Romania**

**January 2012**

**T14-001-  
01/305-F**

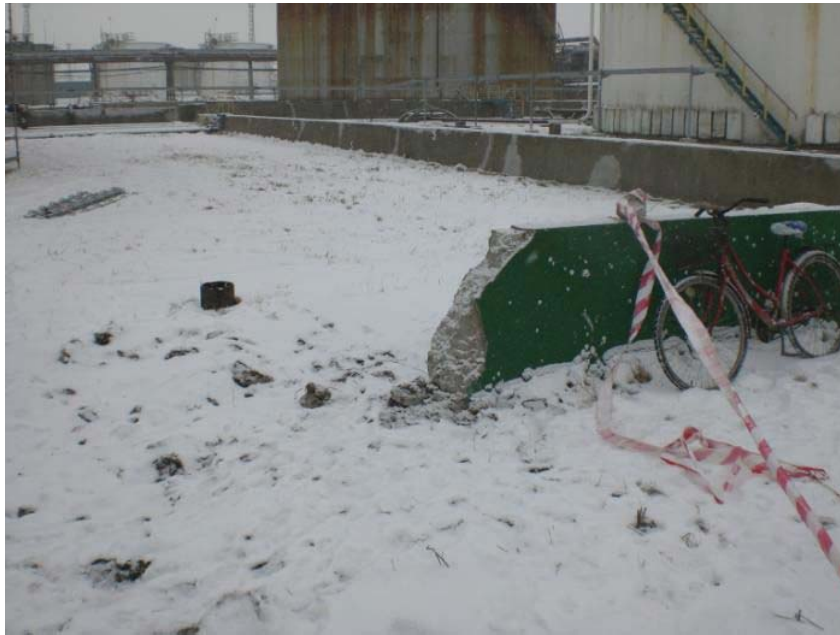
Pic 2: Broken dike wall.

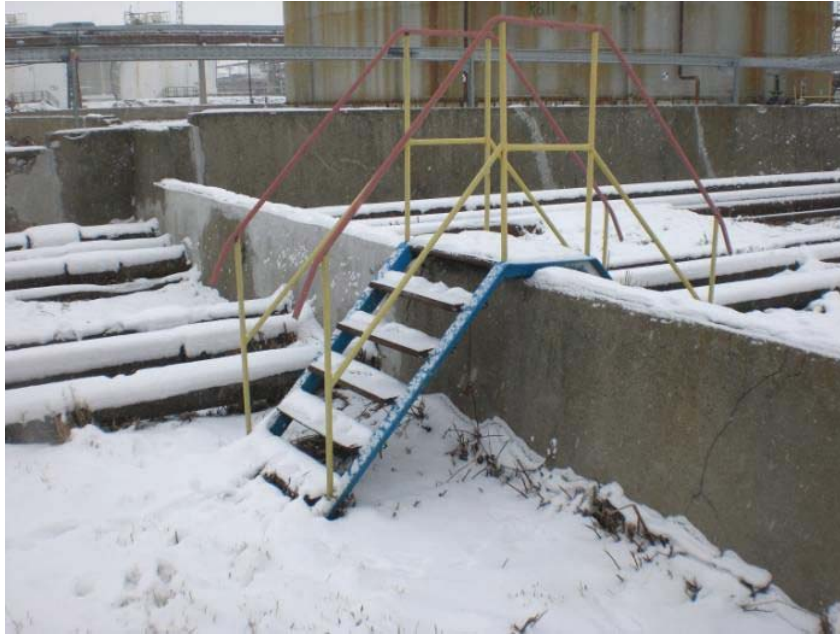
Pic 3: Access Structure, crack in dike wall.

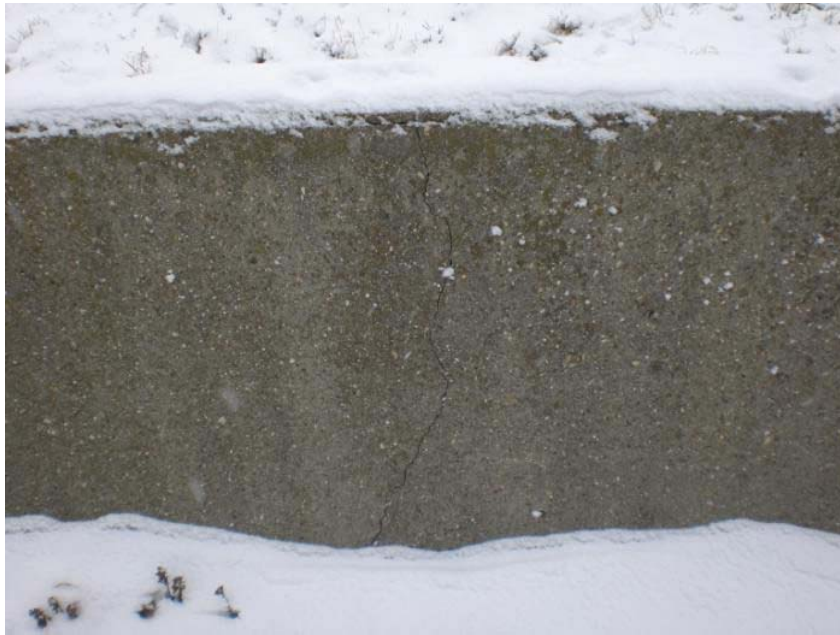
Pic 4: Crack in dike wall over whole height.

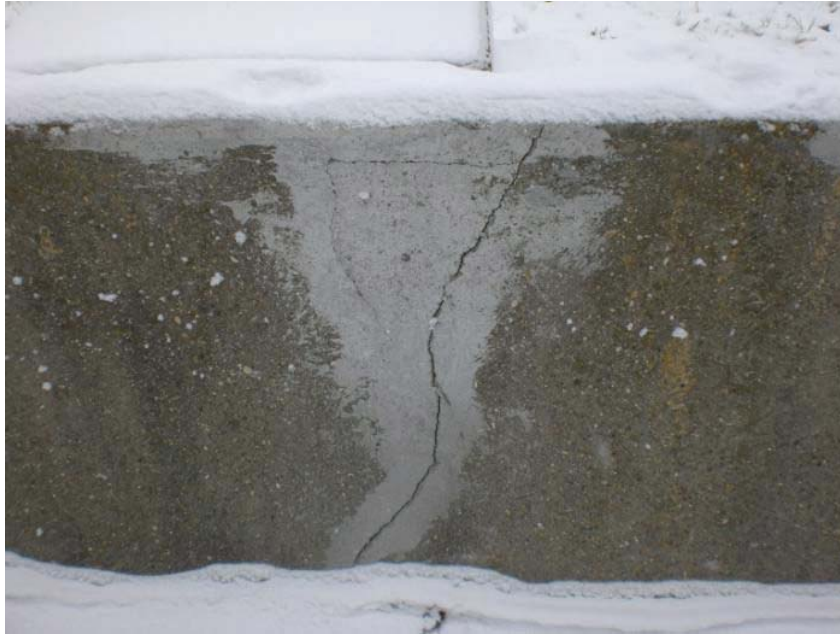
Pic 5: Previously repaired (?) crack in the dike wall.

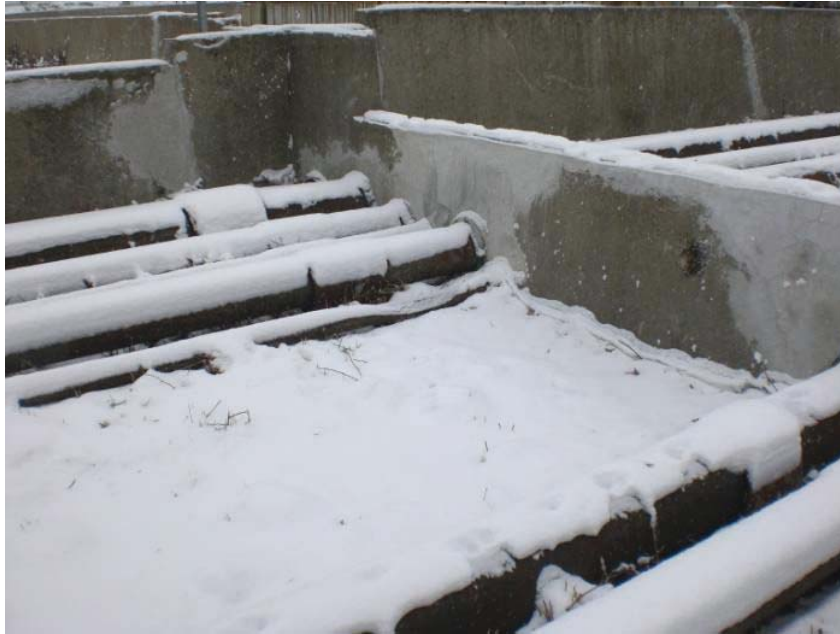
- Heavy vegetation has been detected all around the tanks circumference (bottom projection) and surroundings. It is recommended to remove the existing and prevent further vegetation build up by proper housekeeping.

Pic 7: Pipe work in the diked area. Pipes are running through metal sleeves and are surrounded by heavy vegetation.

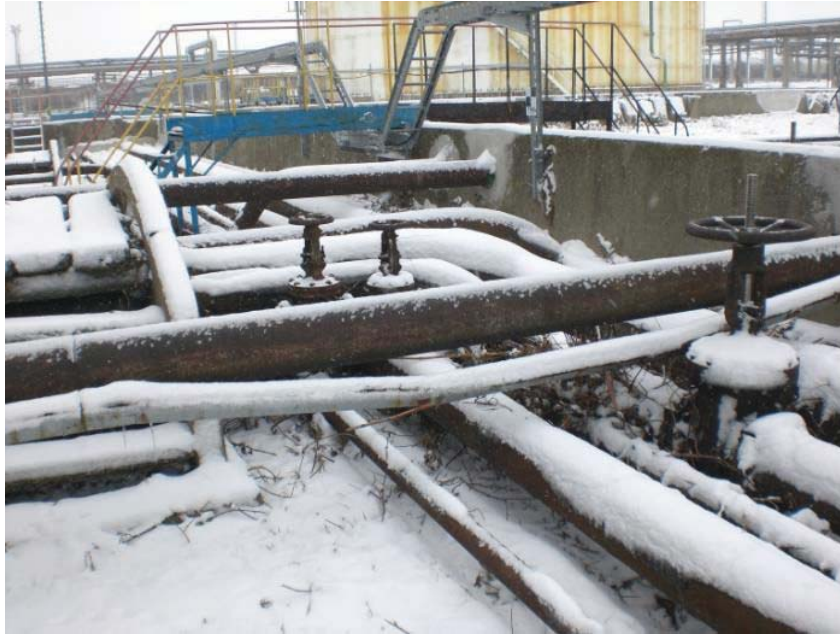
Pic 9: Pipe work, concrete bridge. Heavy vegetation is present all over.

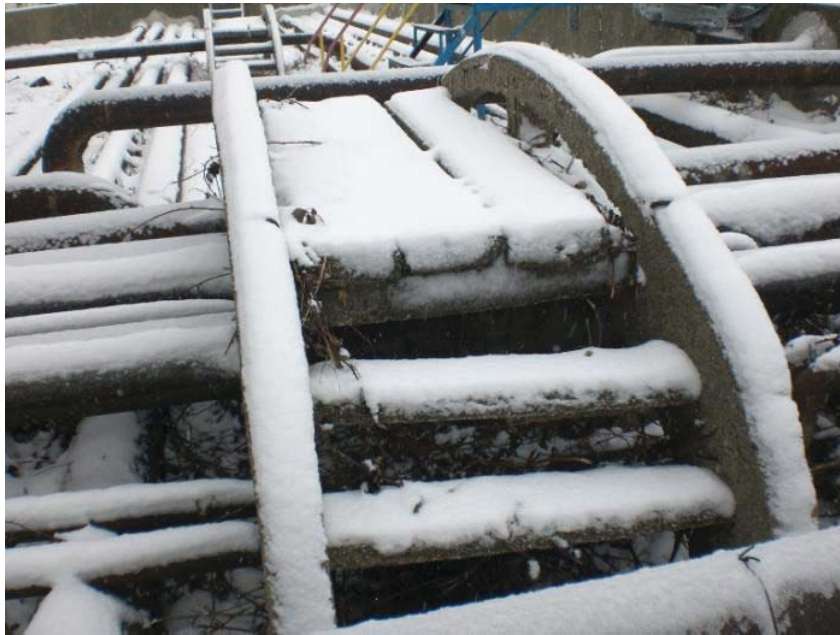
Pic 10: Misaligned concrete bridge. No handrail.

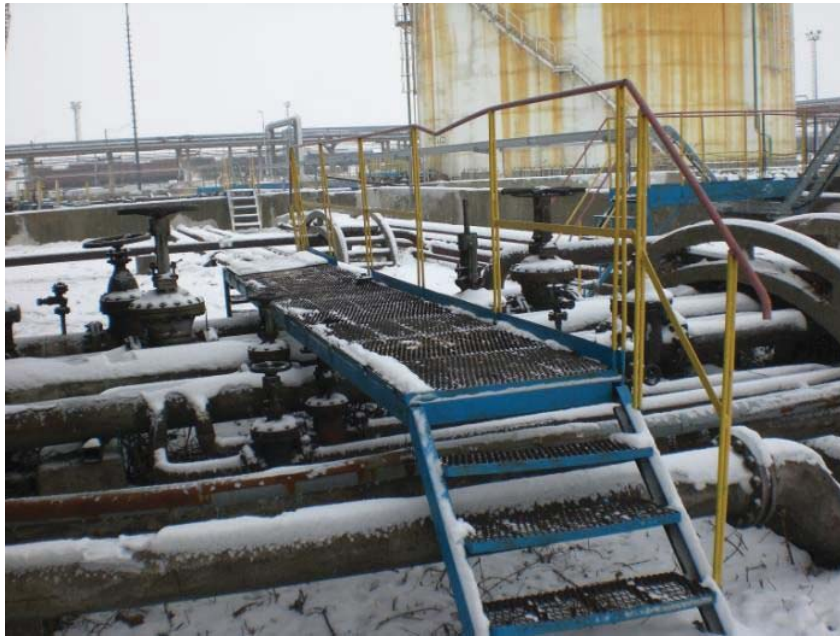
Pic 11: Misaligned, corroded and distorted bridge over pipe work. Handrail facing the tank missing.

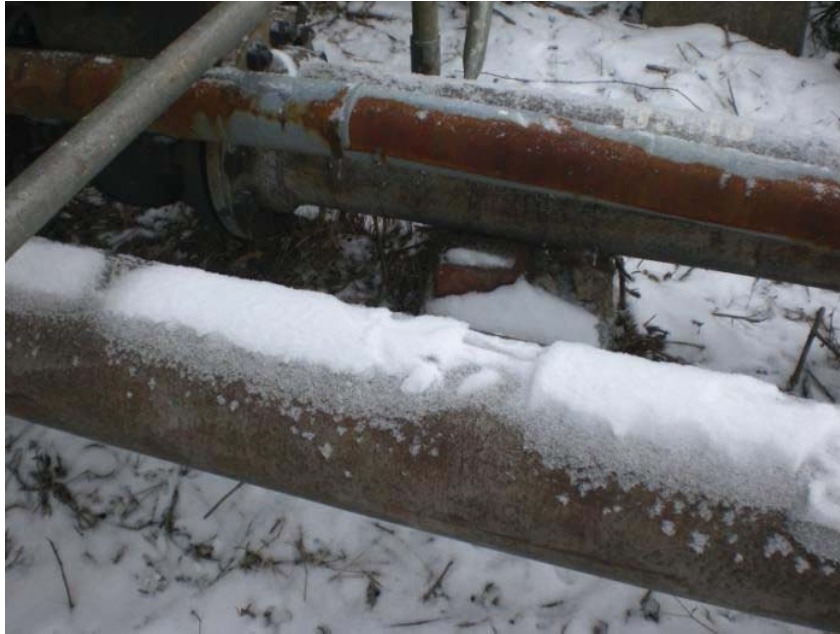
- The pipe supports in the diked area of Tank 305 are of bad design. Piping is lying directly on the concrete support or metal beams which causes coating failure and crevice type / contact corrosion. No U-Bolts are in place to prevent lateral movement. Consideration should be given to modify the pipe supports so that they meet the requirements of ASME B 31.3, e.g. welded on steel shoes at the pipe-support contact area or applied plastic

Pic 13: Pipe work lying on a concrete brick.

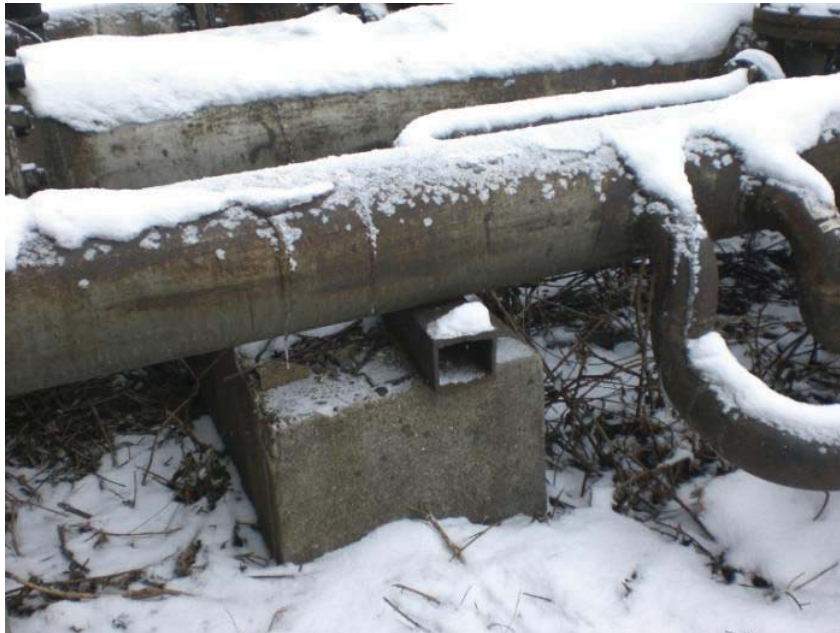
Pic 14: Pipe work lying on a metal beam.

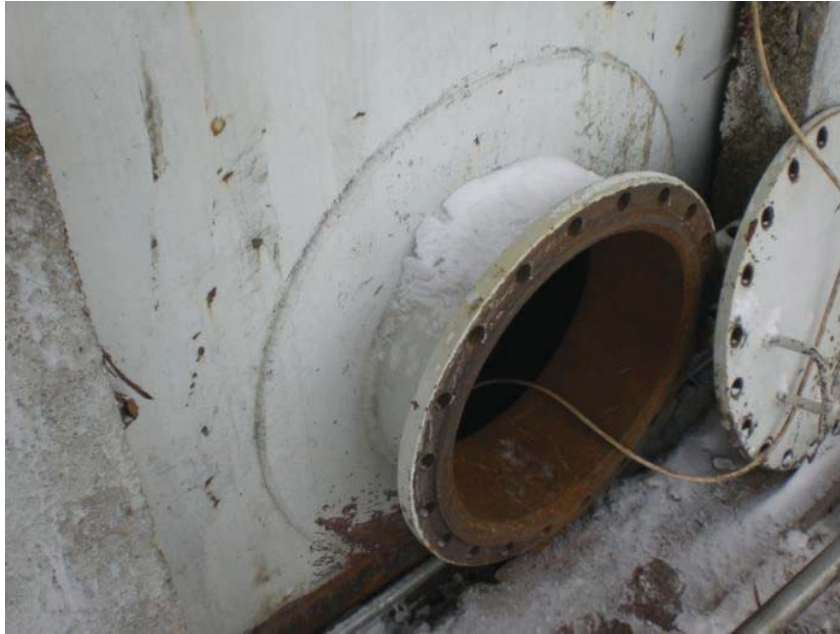
- None of the reinforcement plates have telltale holes (See table 2.1.4.2). API 650, Para 5.7.2.10 indicates reinforcing plates should be installed with telltale holes left open to the atmosphere. It is recommended that the holes be drilled, but before the tank is returned to service, the reinforcing plates shall be tested by applying up to 100 kPa gauge pneumatic pressure between the tank shell and the reinforcement plate on each opening using the telltale. While each space is subjected to such pressure, a soap film, linseed oil, or another material suitable for the detection of leaks shall be applied to all attachment welding around the reinforcement, both inside and outside the tank (API 650, Para 7.3.4). The telltale holes should then be left open to the atmosphere.

Pic 17: Manhole. No telltale hole present in the reinforcement plate.

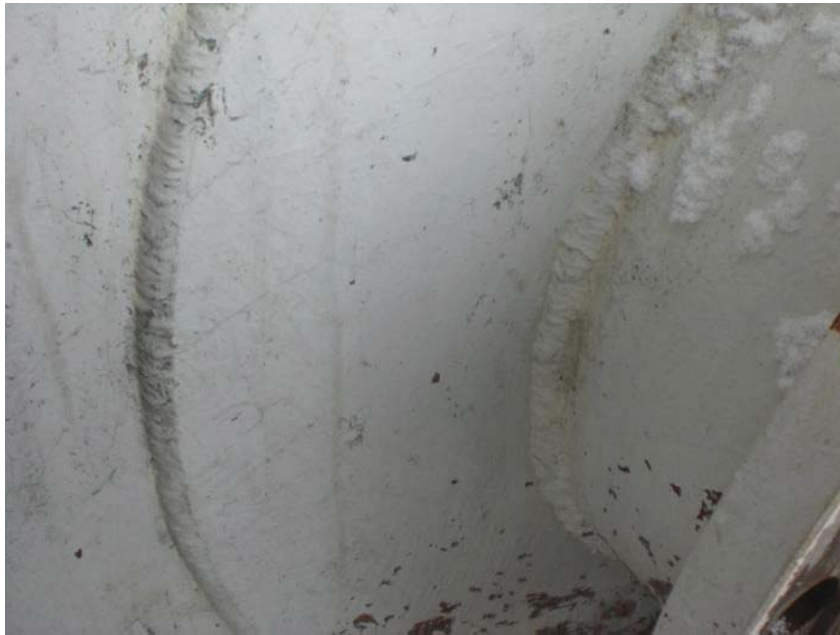
Pic 18: Satisfactory weld work on the manhole.

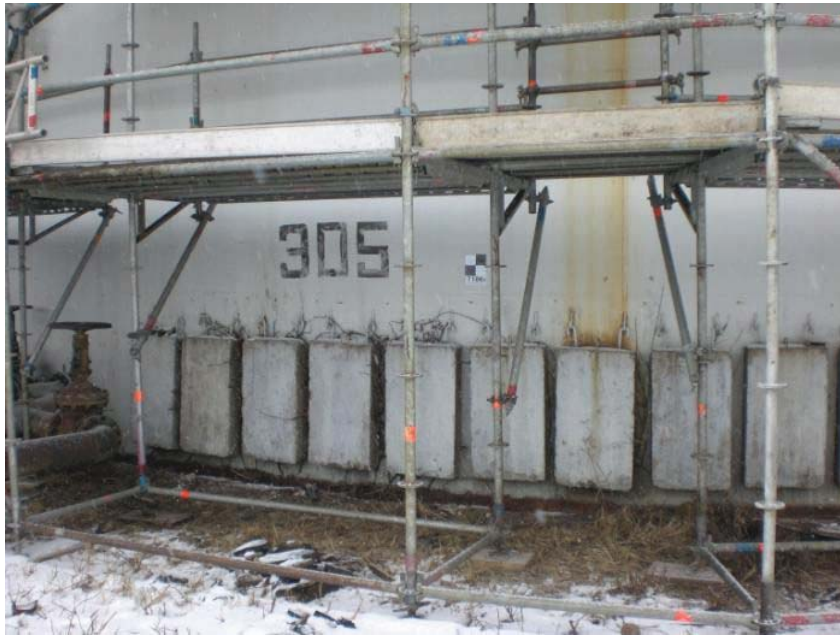
- Several concrete blocks (dimension 900 x 500 x 150 mm) are attached to the bottom shell course, equally spaced around the circumference. The blocks itself are not anchored to the foundation by any means (thus a self-anchored tank) and therefore either seen as ballast against uplift by the combination of wind forces and internal pressure (see API650, Sections 5.11 for more details) or for resistances against earthquake. It would be worthwhile to seek consultancy with a tank engineer with national earthquake calculation experiences to check current suitability (and compliance with the national structural design standards since the national standard will be govern above the API650 requirements). The report and any modification shall be part of the tank record system for future references. The blocks are not endangering the technical integrity of the tank and therefore no further inspection or maintenance actions to be defined at this stage.

Pic 22: Concrete blocks hanging all over the tank circumference.

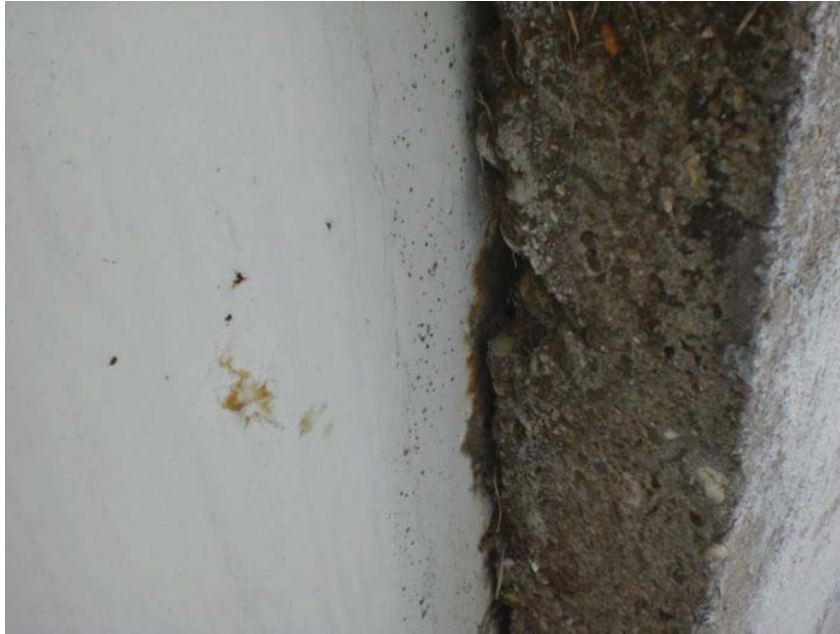
Pic 23: Vegetation behind concrete block.

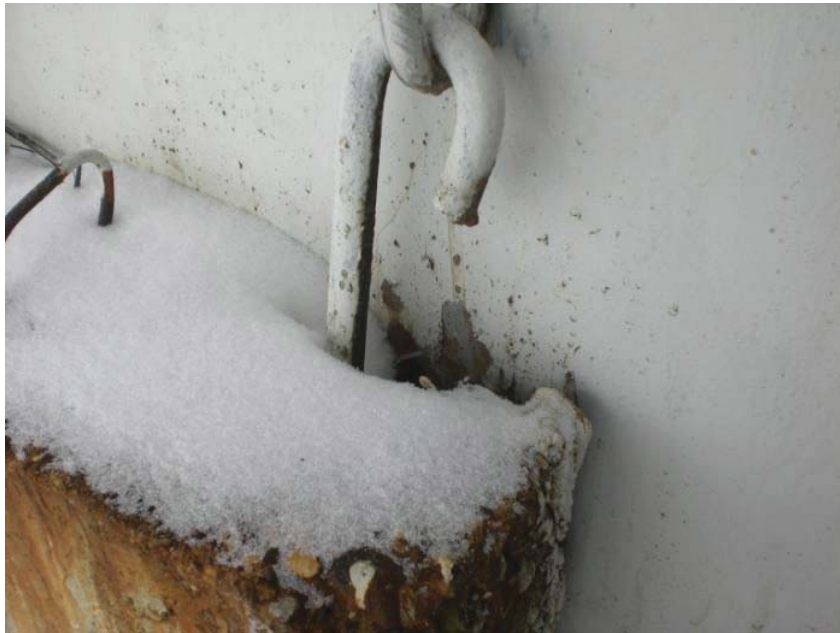
Pic 24: Concrete block connection. Paint failure and beginning corrosion on the shell plate.

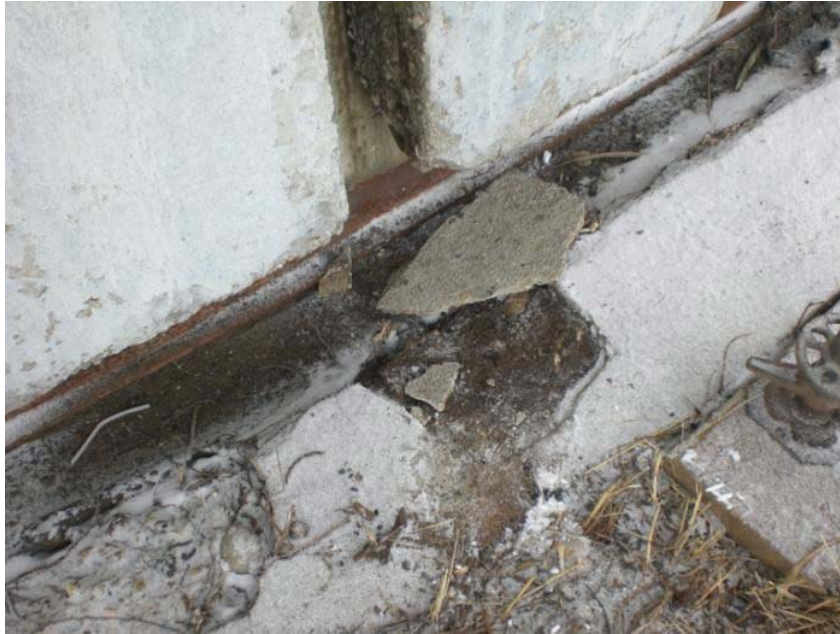
- The tank is standing on a concrete ring / gravel foundation, in level with the ground.
- The ring is in a poor to doubtful condition; heavy spalling and cracking has been detected all over the circumference. There is a gap of about 100 mm between the concrete ring and the bottom projection. The foundation sand underneath the tank is partially washed out so that water can ingress easily underneath the tank. In addition to that, several voids have been observed between the tank bottom and the foundation. It is recommended to install a suitable moisture barrier (Bottom to foundation seal) to prevent water migrating under the bottom. In addition to that, consideration can be taken to let the foundation be reviewed by a civil engineer.

Pic 25: Damaged concrete ring, big gap between concrete ring and tank bottom projection.

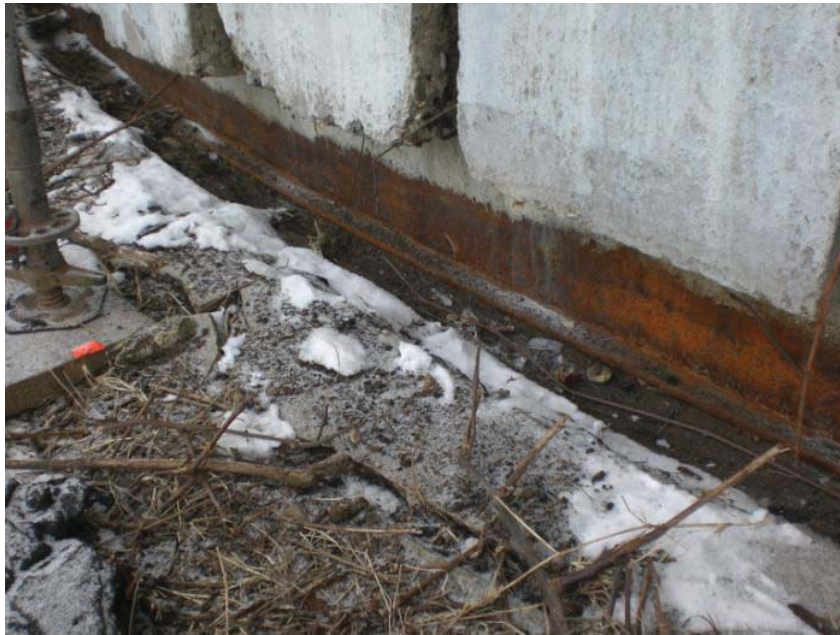
Pic 26: Damaged concrete ring, heavy vegetation. Soil under the tank bottom washed out.

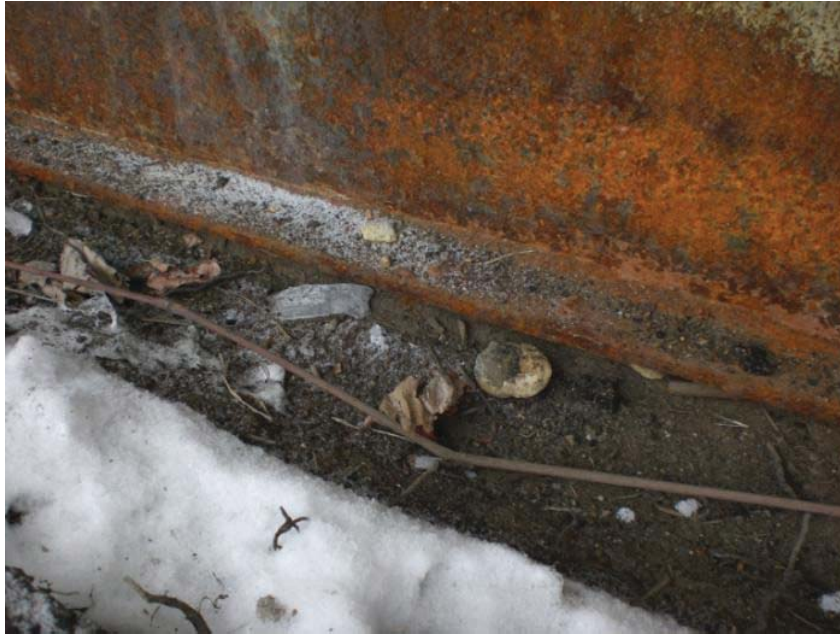
Pic 27: Foundation close up. Bottom projection in fair condition, however soil washed out and gravel visible.

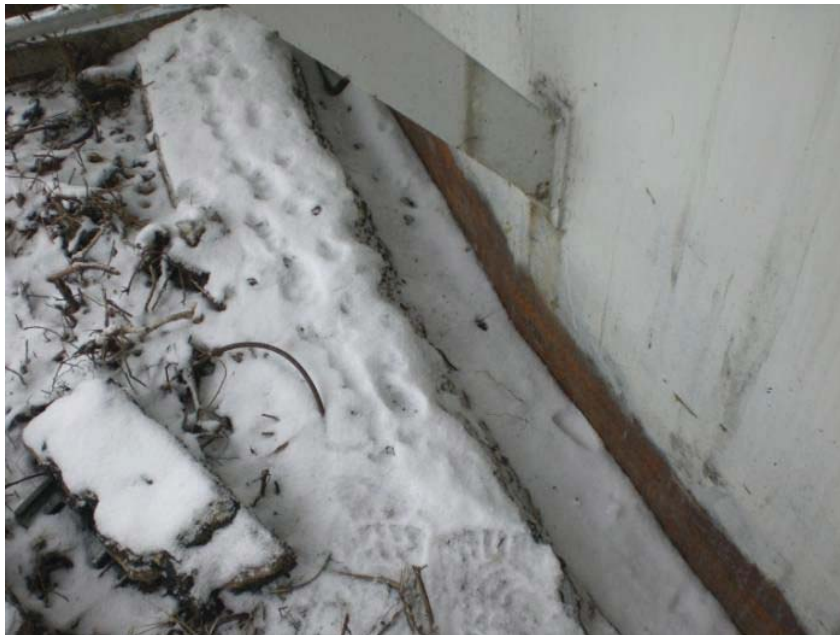
Pic 28: Tank settled about 70 mm into the foundation.

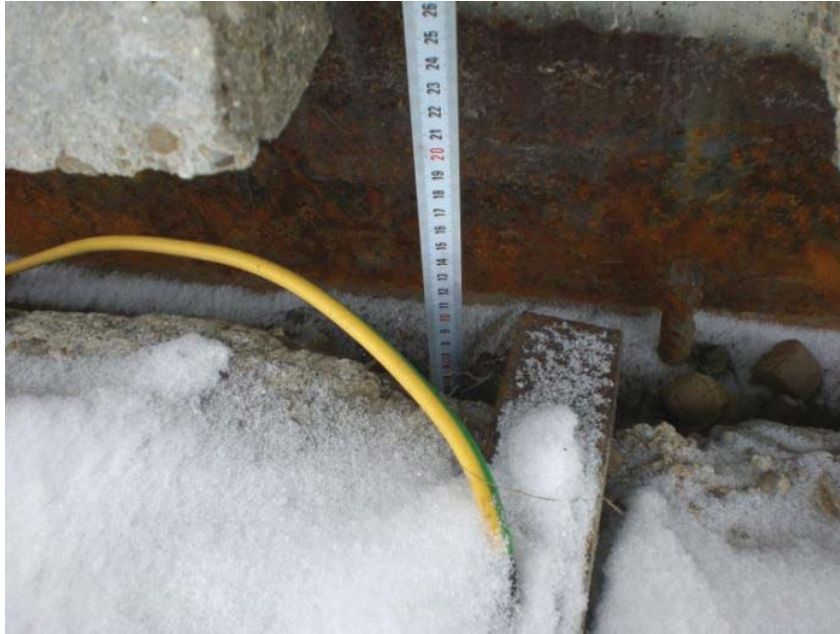
Pic 31: Grounding strap, about 80 mm settlement.

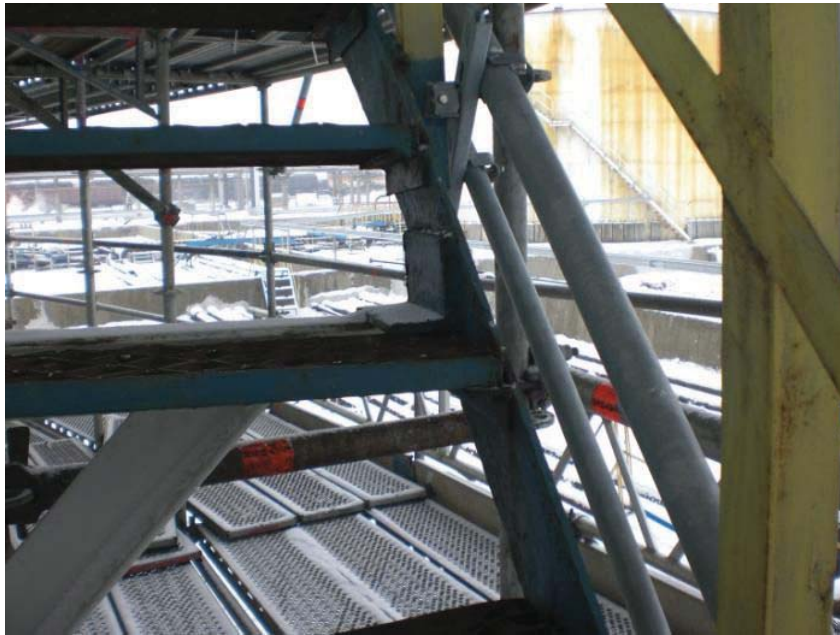
Pic 32: Spiral stairway in fair condition; minor paint failure and corrosion visible.

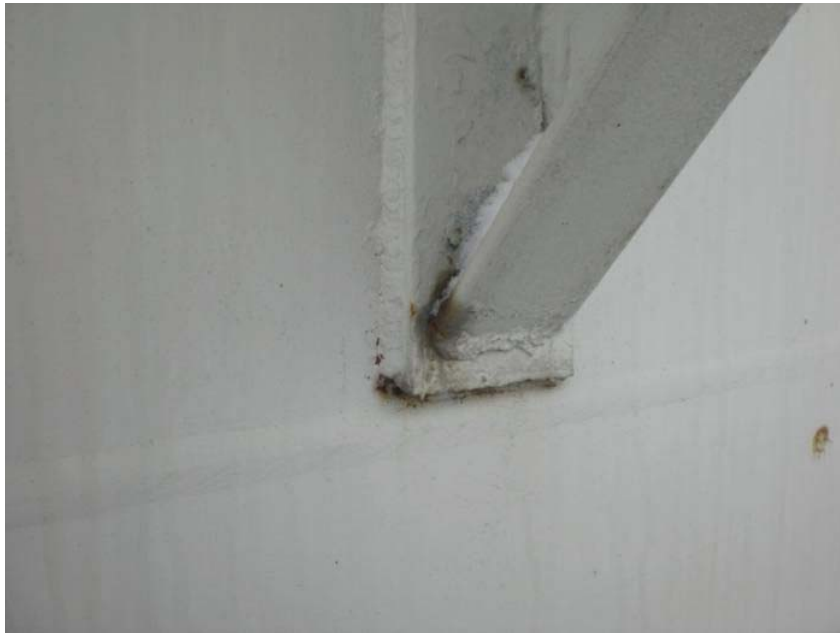
Pic 34: Support for spiral stairway, lack of weld space.

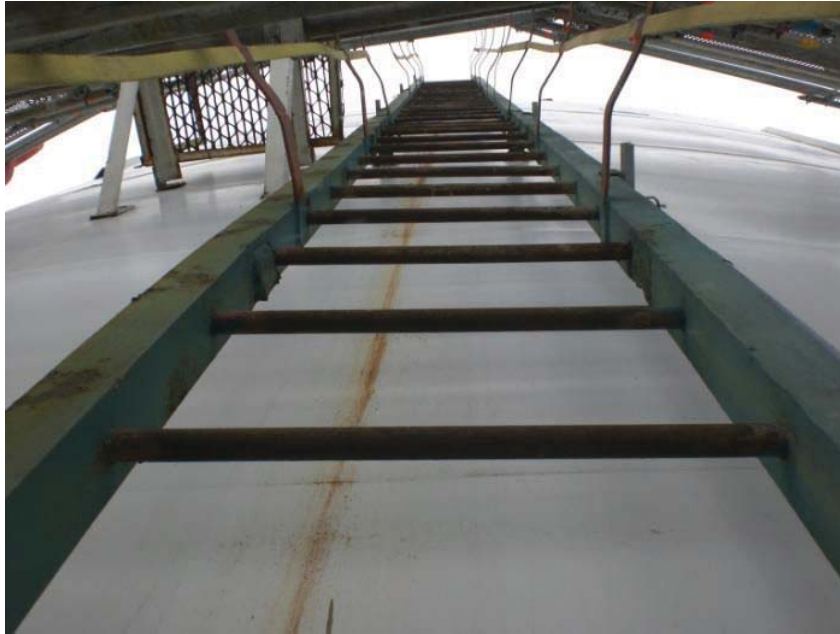
Pic 35: Vertical ladder, slightly misaligned.

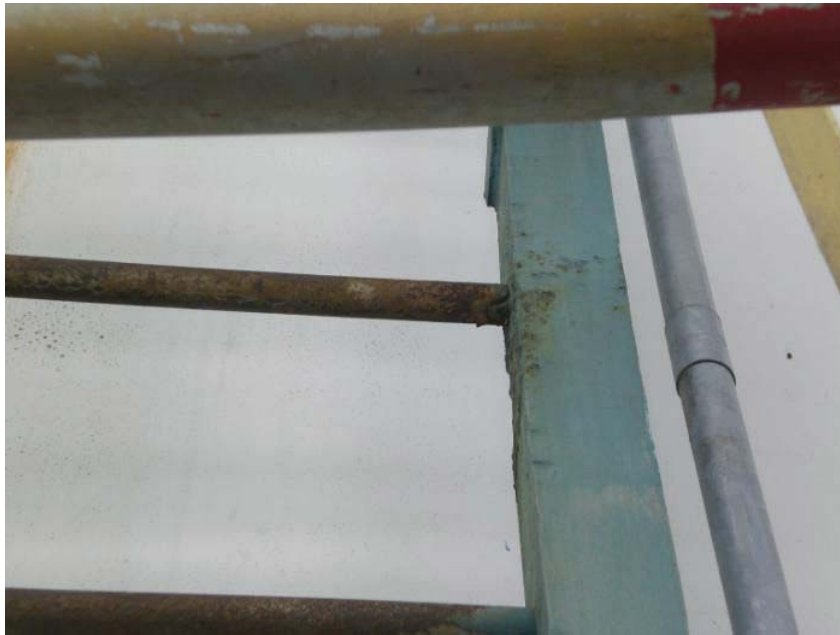
Pic 36: Corroded rung connection.

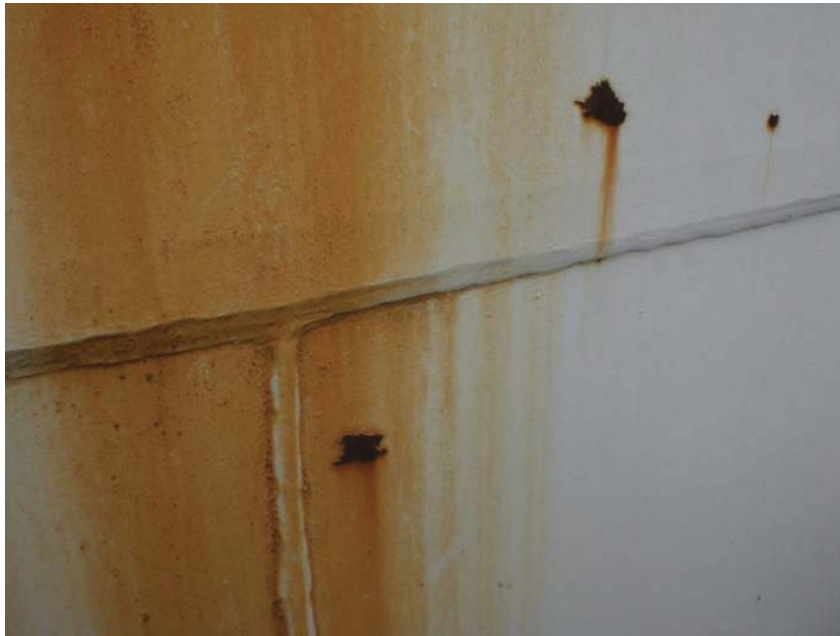
Pic 37: Paint failure, corrosion and product stains on the shell. Origin of staining is the roof, however exact location unknown.

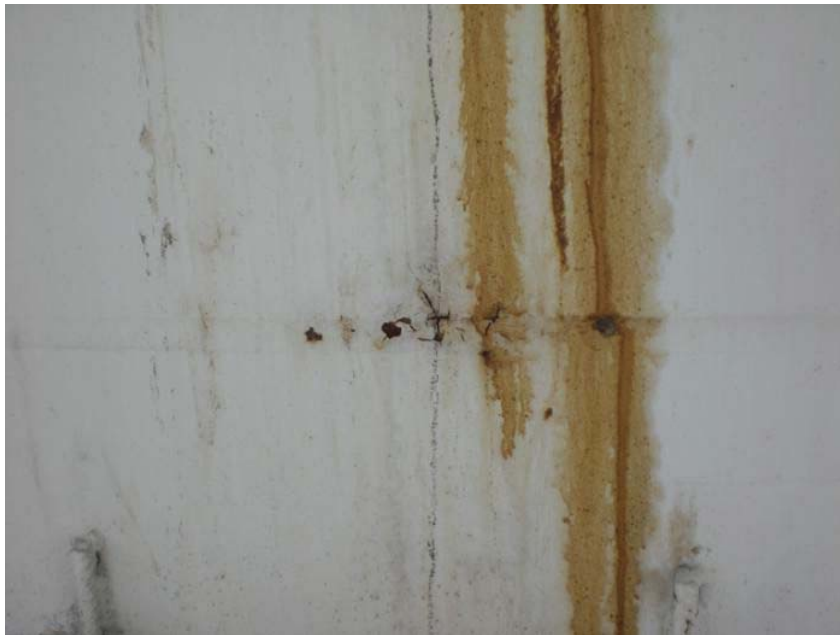
Pic 38: Product stains, paint failure, corrosion.

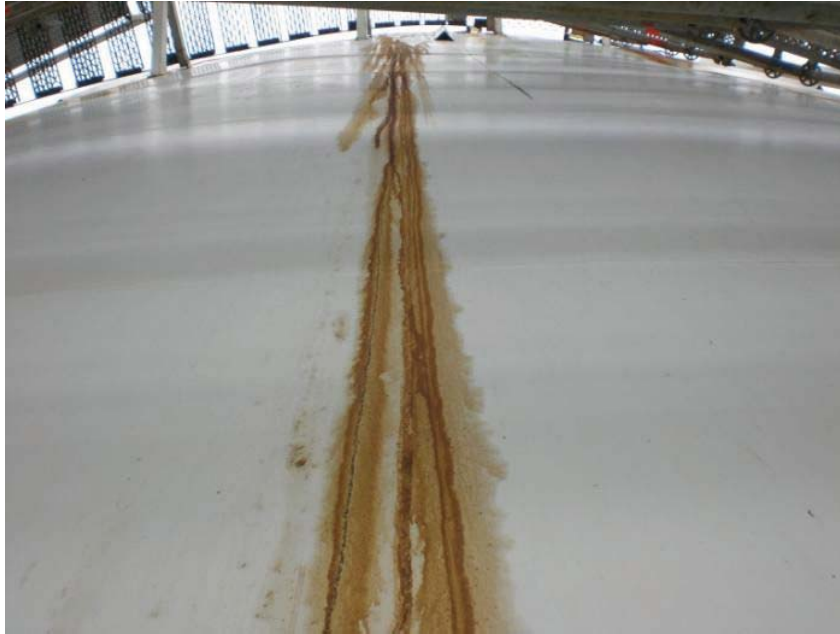
Pic 39: Product stains coming from the roof.

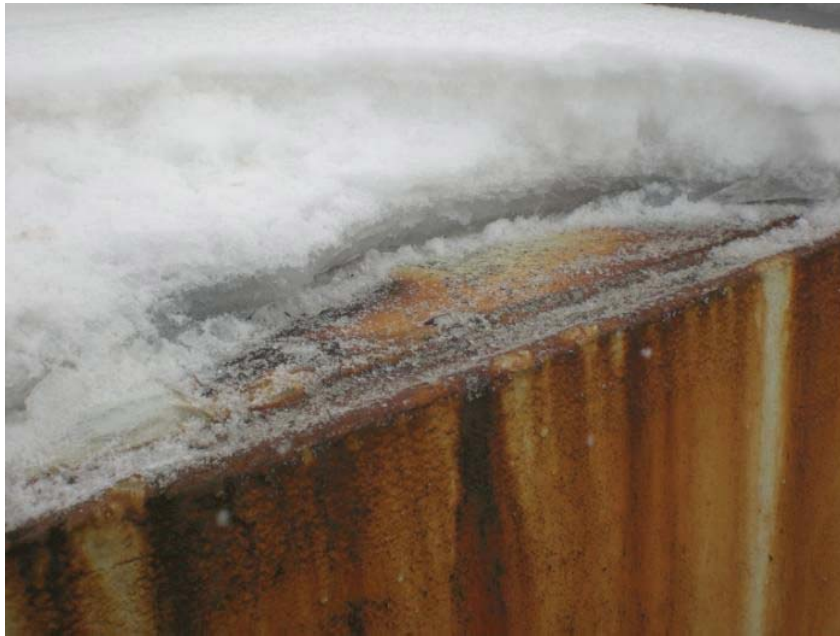
Pic 41: Roof to shell connection. No Top Curb Angle (TCA) present.

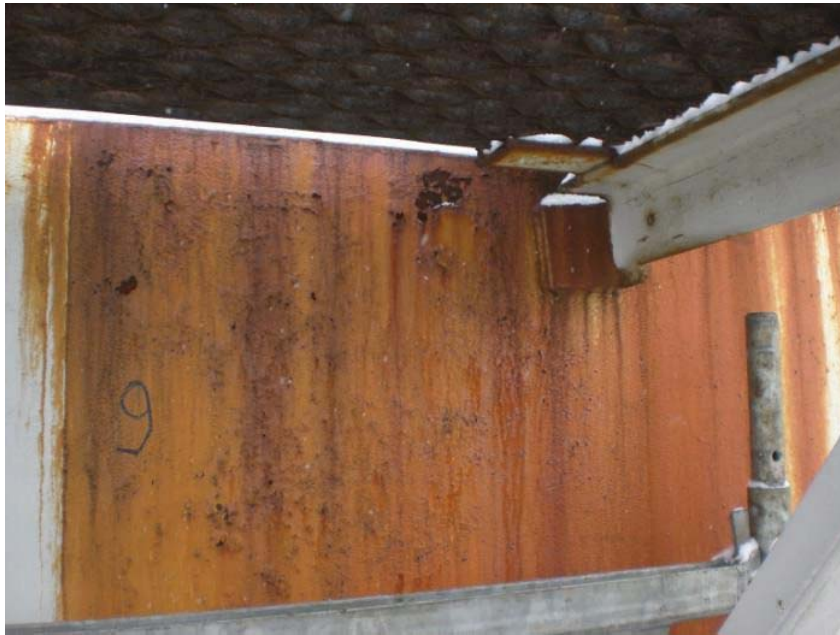
Pic 42: Paint failure and corrosion at the top of the shell.

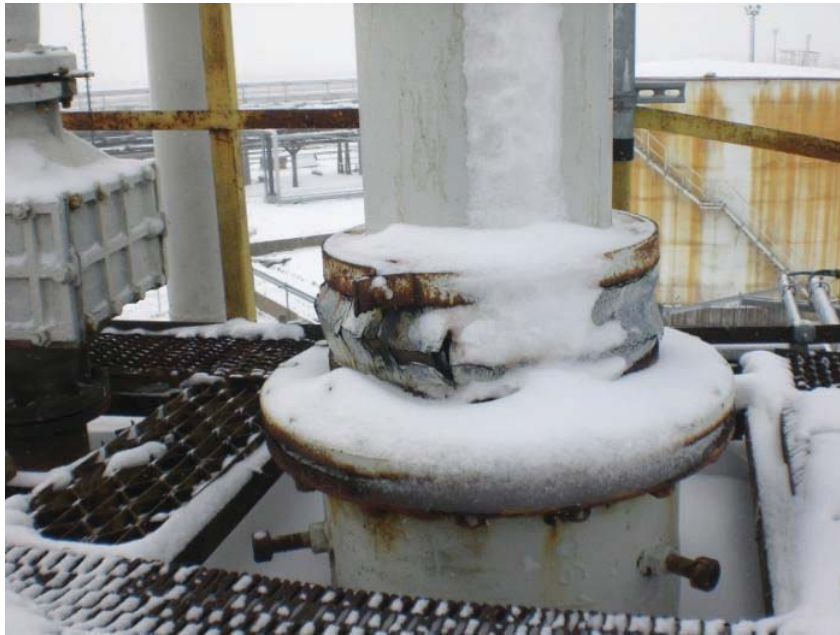
Pic 44: ATG (Radar) connection damaged.

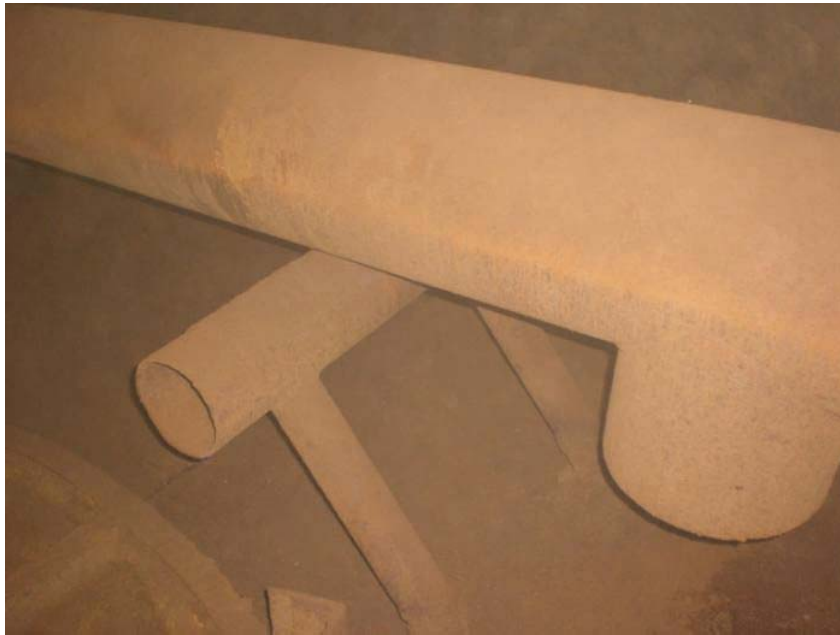
Pic 50: Outlet swivel. Support not fully welded to the bottom.

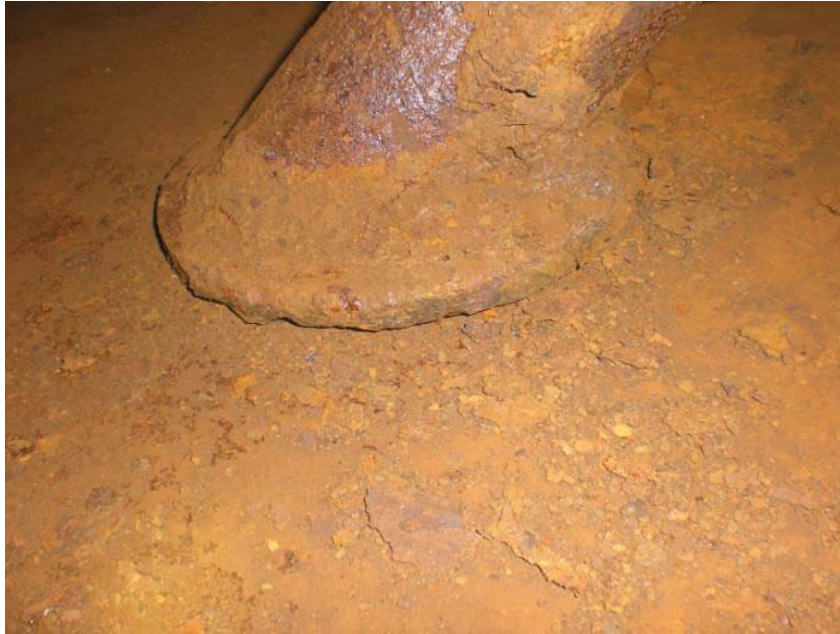
Pic 51: Swivel support pads not seal welded to the bottom plate.

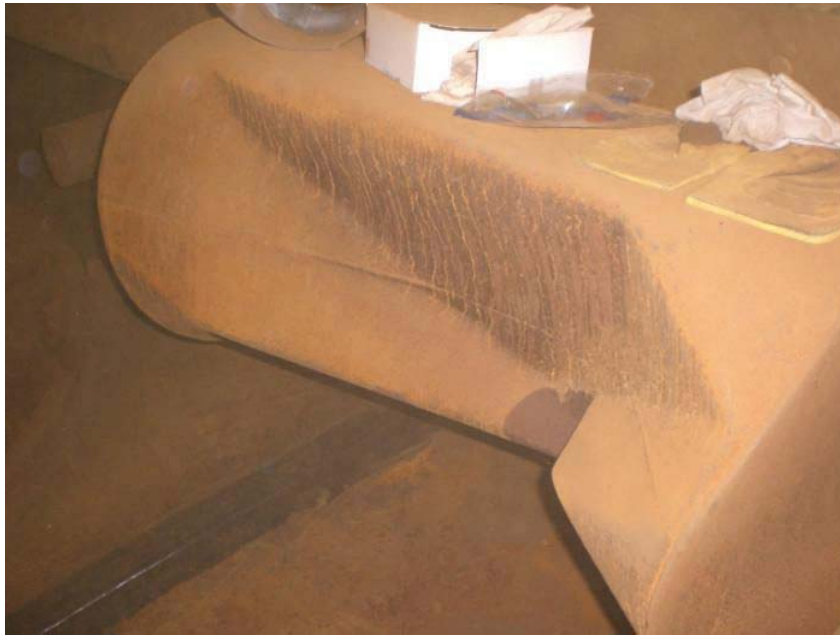
Pic 52: Massive deformation of the swivel floaters.

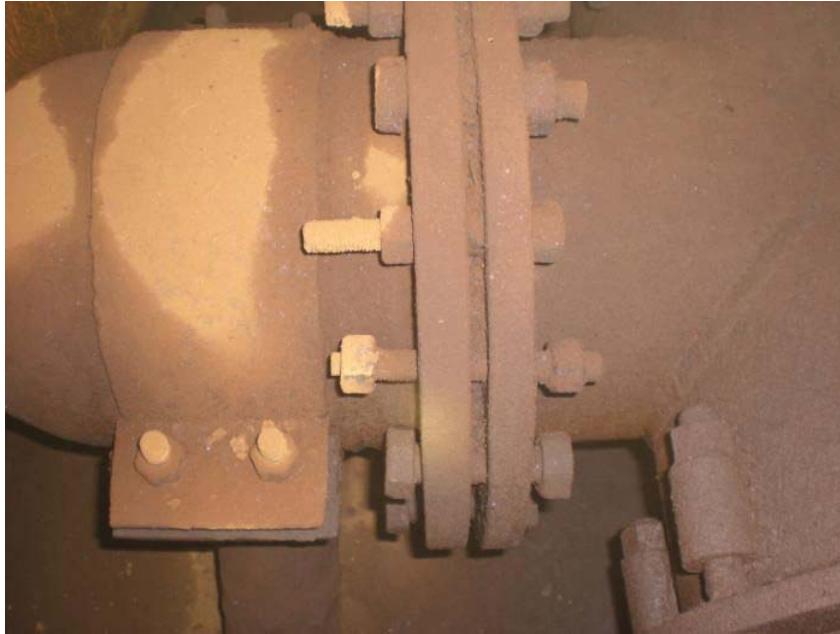
Pic 53: Bolts not properly tightened on the outlet connection.

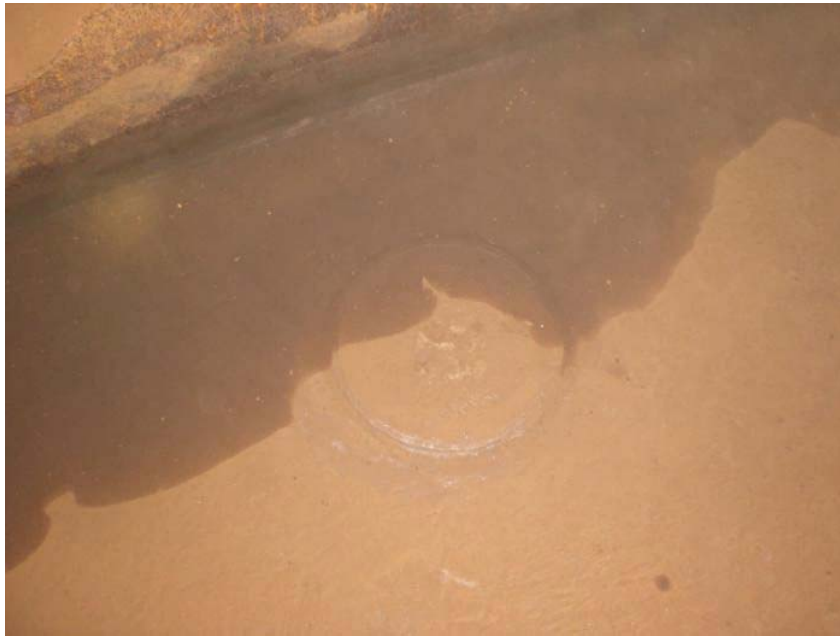
Pic 55: Patch plate or abandoned striker plate.

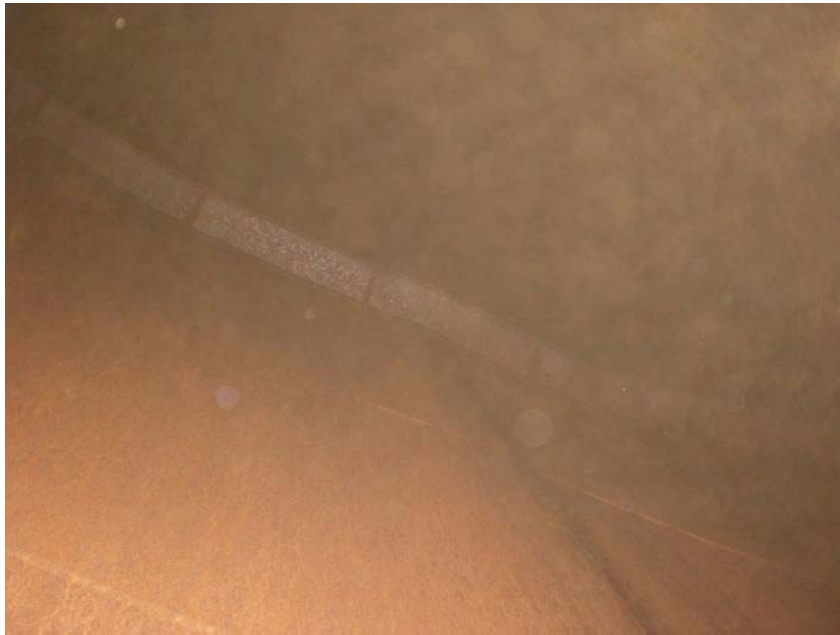
- One wind girder is attached to the inside of the shell. The dimension is unknown, it is placed about 6.7 m above the bottom. Due to the construction of the shell with one vertical lap weld from the bottom to the top the wind girder is distorted in the vicinity of this weld and a gusset plate next to the weld is loose. It is recommended to re-attach the gusset plate.

Pic 58: Shell and wind girder deformation in the vicinity of the vertical shell weld.

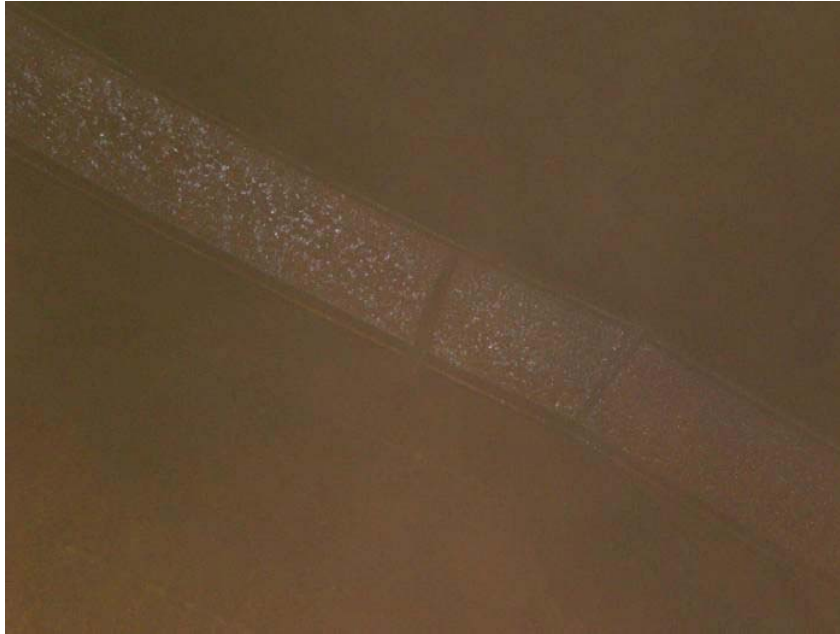
Pic 59: Loose gusset plate due to deformation.

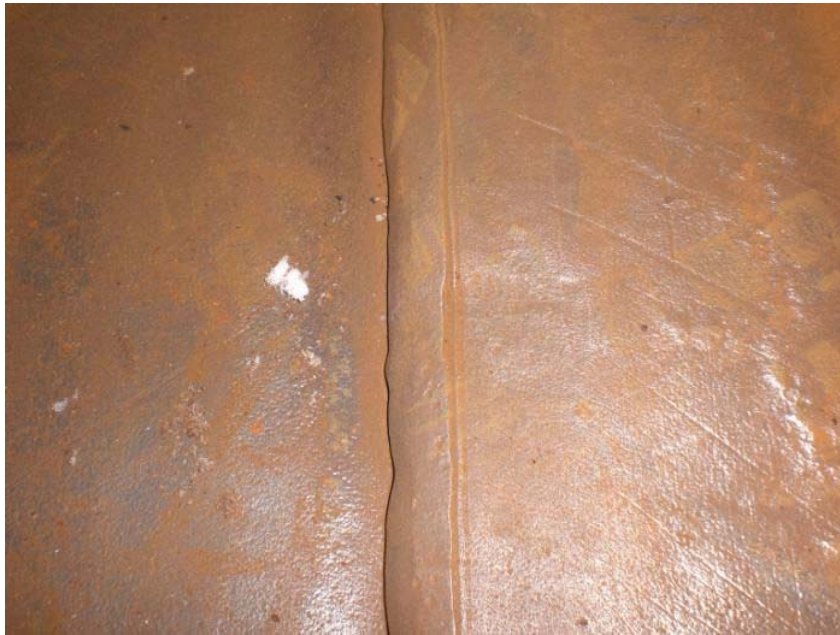
Pic 60: Heavy undercut and lack of fusion at the bottom welds.

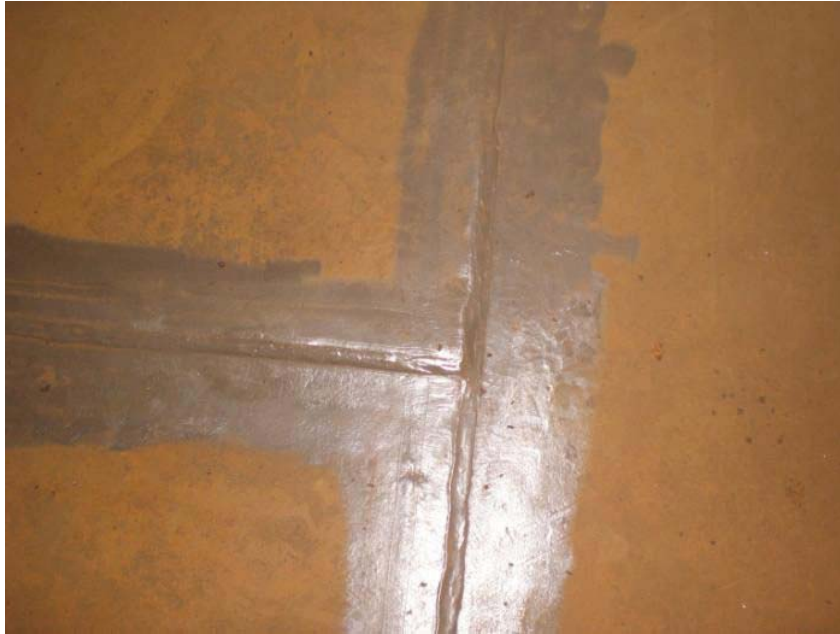
Pic 61: Undercut and underfill present on the bottom welds.

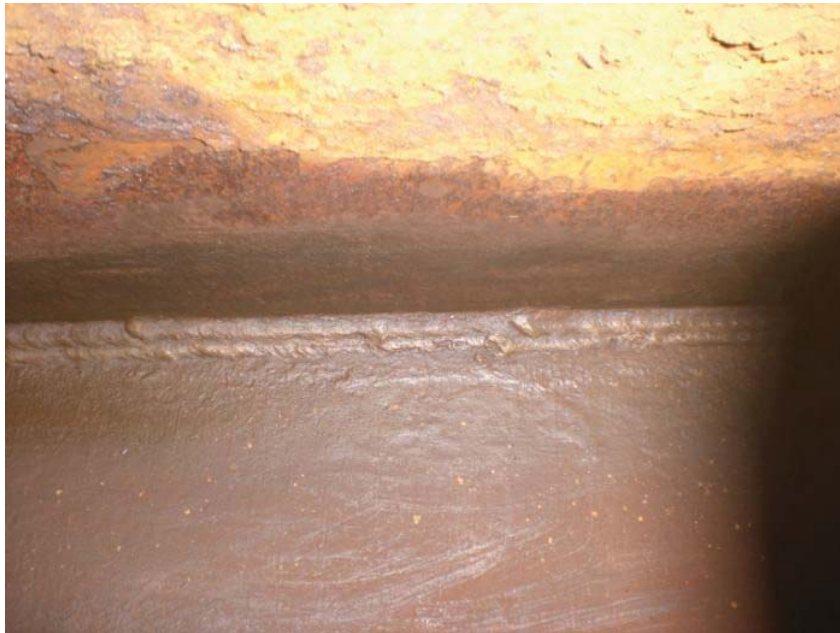
Pic 62: Poor weld work of the corner weld.
