# **TANK 305 API 653 TANK INSPECTION Final Report**

**Ploiesti, Romania**

**January 2012**

**T14-001-  
01/305-F**

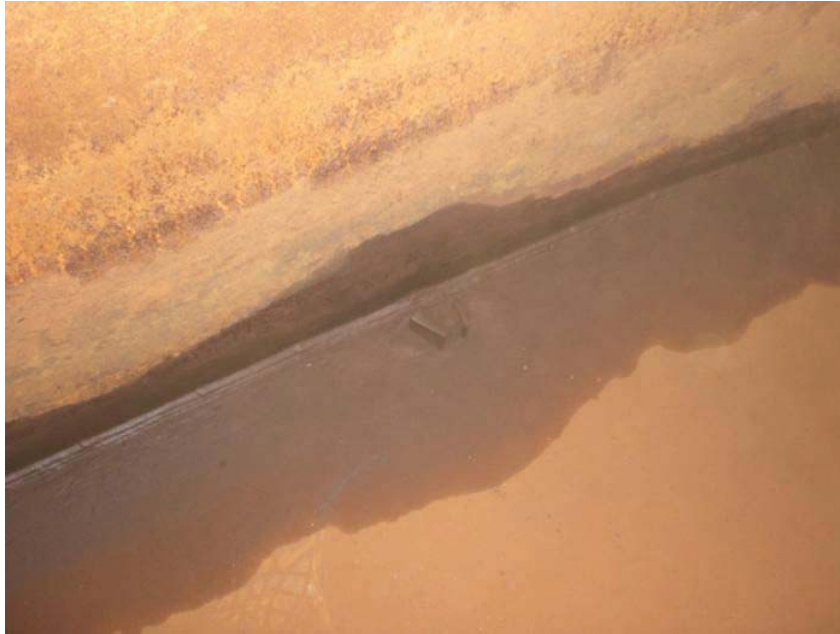
Pic 63: Abandoned beam remains in the critical zone.

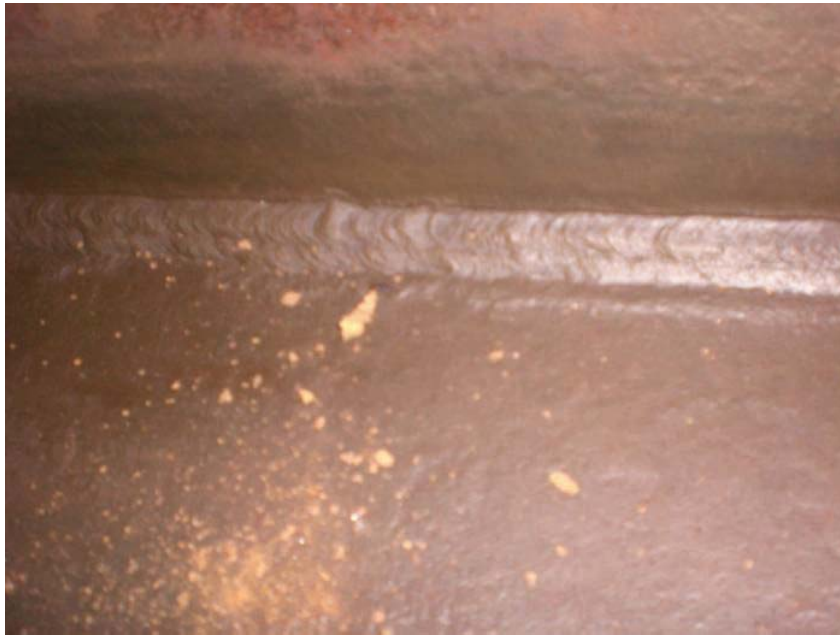
Pic 64: Undercut on the corner weld.
